725DA-SS, 725DA and Piston Valves Maintenance & Parts Guide

Valve Disassembly and Reassembly Procedures

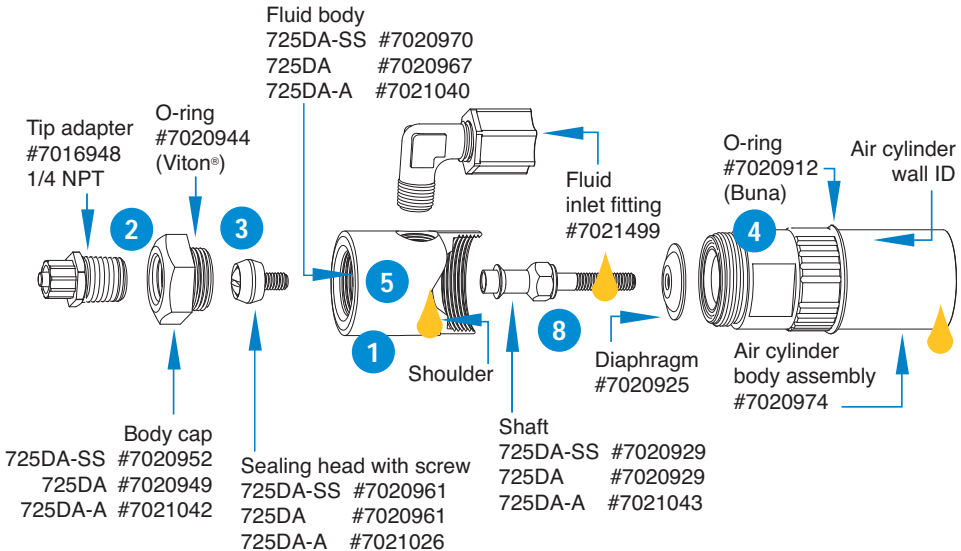
1. Put threaded rod in mounting hole.
 2. Remove body cap.
 3. Remove sealing head.*
 4. With a wrench on the flats of the air cylinder body, turn to loosen fluid body.
 5. Remove fluid body.*
 6. Remove input air hose from push-in fitting on air cap.
 7. Insert 1/8" hex wrench through air inlet hole in cap and back shaft locking screw out two turns.*
 8. Using the the hex on the shaft, unthread shaft, and remove shaft and diaphragm.*
 9. Unscrew air cyclinder cap from air cylinder body.*
 10. Remove piston and spring.
- Note:** Stroke adjustment ring on the valve air cylinder assembly is not removable. If this assembly requires repair, it must be returned to EFD.

Note: Before reassembling valve, clean all parts, replace O-rings, sealing head and diaphragm.

Inspect for damaged threads, piston pins for straightness and fluid body seat for pitting.

Reassemble the valve in reverse order of disassembly. Lubricate parts indicated with Nye Lubricant #865 included in the General Maintenance Kit.

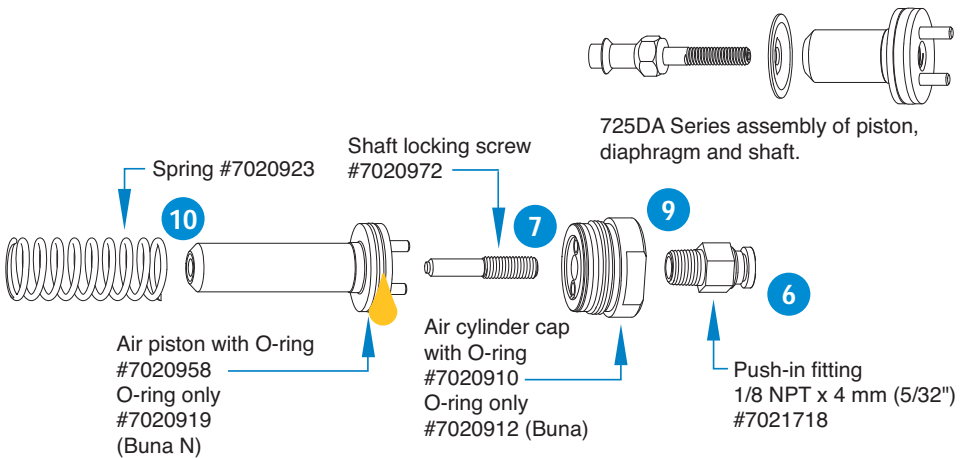
step	part	newton meters	(inch pounds)
3	Sealing head screw	1.69 Nm	(15 inch pounds)
5	Fluid body	6.78 Nm	(5 foot pounds)
7	Shaft locking screw	2.82 Nm	(25 inch pounds)
8	Shaft	1.69 Nm	(15 inch pounds)
9	Air cylinder cap	10.8 Nm	(8 foot pounds)

* Parts that require a specific torque when reassembling the valve.
